CHEMICAL EXPLOSION AT IQOXE IN TARRAGONA

Incident Investigation Report

Report No.: 2020-9184, Rev. 1

Date: 2020-10-09

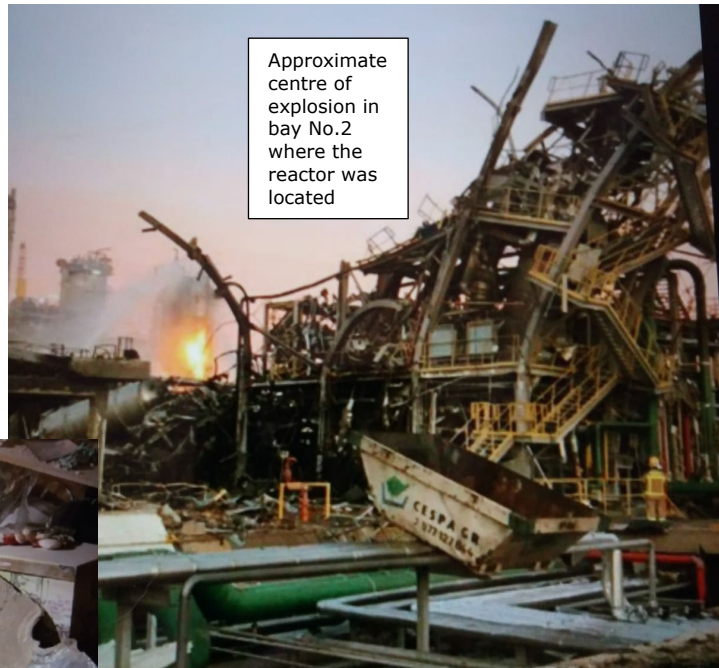
Figure 3-3: U3100 directly after the explosion

Comparing the damage to the steel structure of U-3100 with the unit prior to the accident indicates a centre of an explosion located in the upper part of the reactor bay. The vertical structural steel has been forced away from the centre of the explosion.

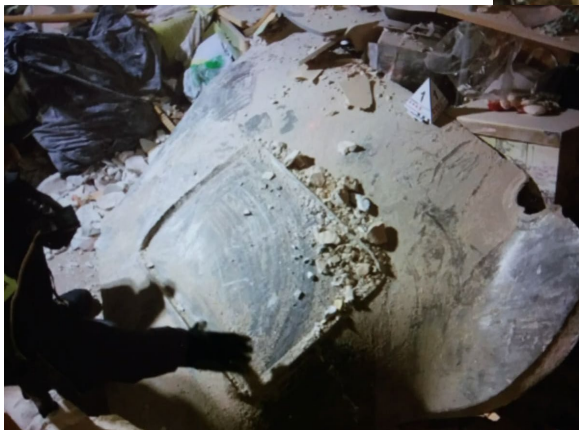
Figure 3-4: plate from reactor found in household in Torreforta

Sadly, two workers of IQOXE, who were working at U3100 died. Furthermore, one person living in the nearby village Torreforta also died, when a plate from the reactor hit his household 2.5km away from plant. Several workers were physically and psychologically injured.

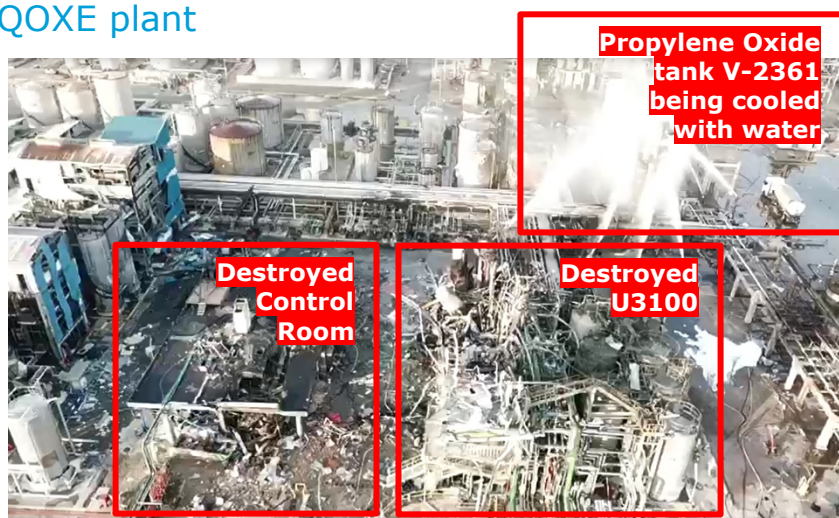
The explosion resulted in overpressure effects, resulting in total destruction of the plant unit U-3100 and the adjacent control room (approximately 25m from the unit boundary to the control room wall.). The preceding fire and the subsequent explosion led to severe distortion of U-3100's structural steel and displacement of main vessels. Lighter damage was caused to buildings

Figure 3-5: Excerpt from video showing the destroyed U3100 and surrounding facilities

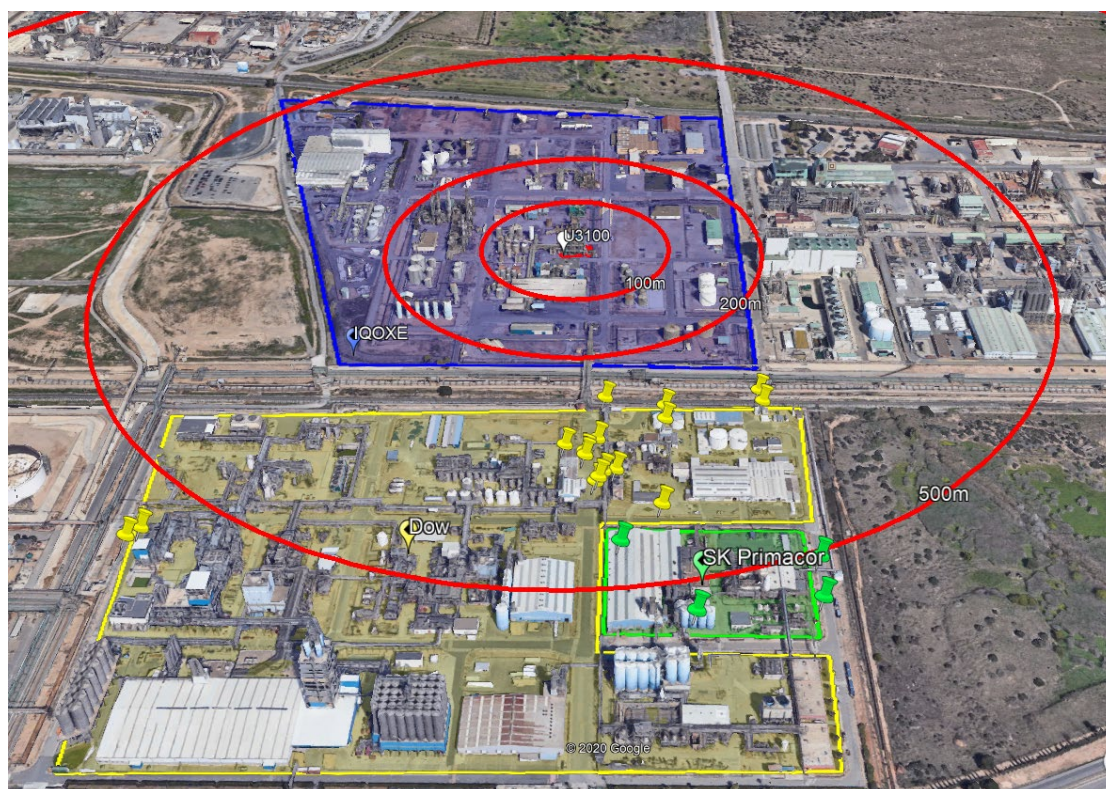
Figure 3-6: Plotted missile fragments to IQOXE and surrounding plants

Most of the fragments are located at the east of the plants. This happens because other directions were blocked by buildings in the IQOXE site itself. Around 40 fragments have been reported, some of them up to 400kg. Most of them were parts of the U3100 structure.

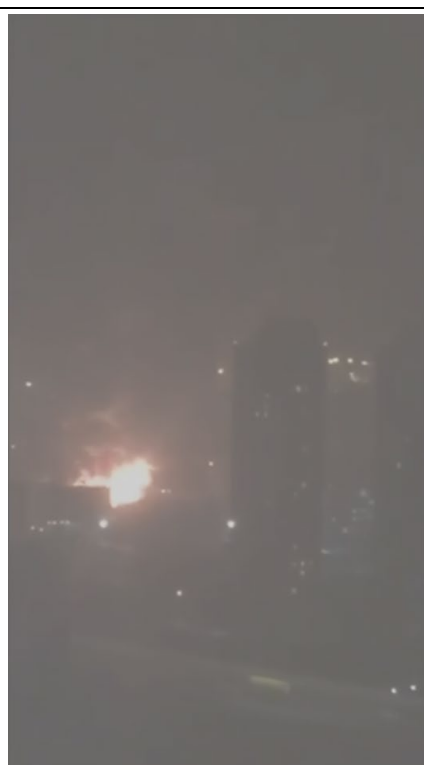
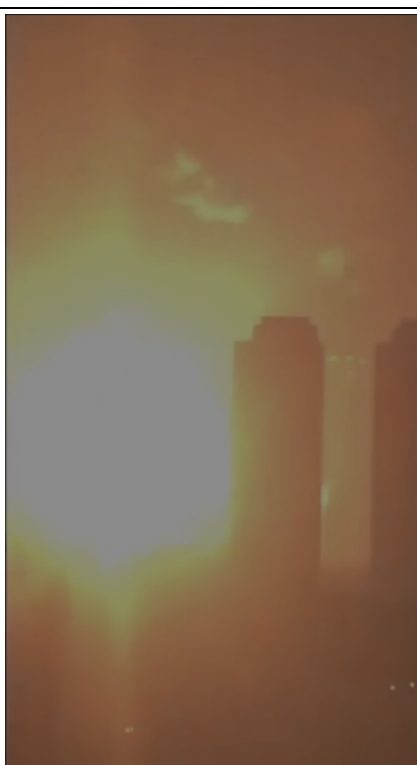
Figure 4-3: Initial scene from external video

Figure 4-4: 1st explosion 20ms later

Figure 4-5: 2nd explosion 2s later

It is not possible to ascertain from the short video whether these are separate moments of loss of containment or 3 stages of the failure of the reactor. Other than the reactor R3131, no vessels showed signs of an explosion.

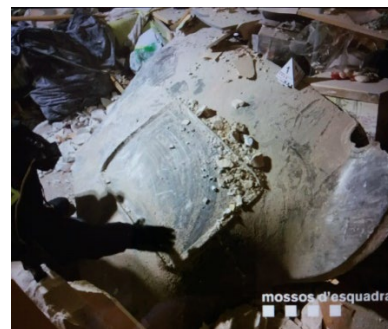
Lastly the fragment that impacted the victim's house, located over 2.5km away from IQOXE weighted around 750-1000kg. The house was located at the east of the facility.

Figure 4-9: Missile fragment of the reactor R3131 landed in Torreforta

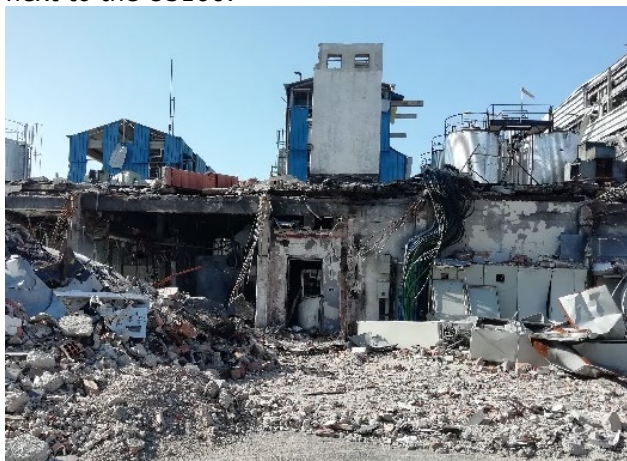
It further partially destroyed the control room 25m next to the U3100.

Figure 4-10: destroyed control room building

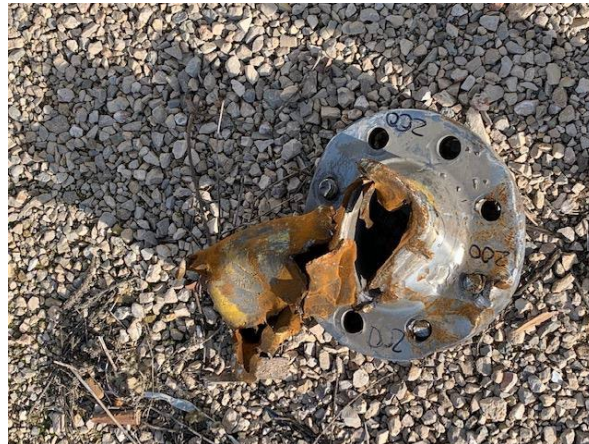
Figure 4-12: FOTOGRAFIA 200

Many of the fragments which are process fittings such as flanges and valves have broken bolts indicating a very high force wrenched them from their installed location. Examples are provided below:

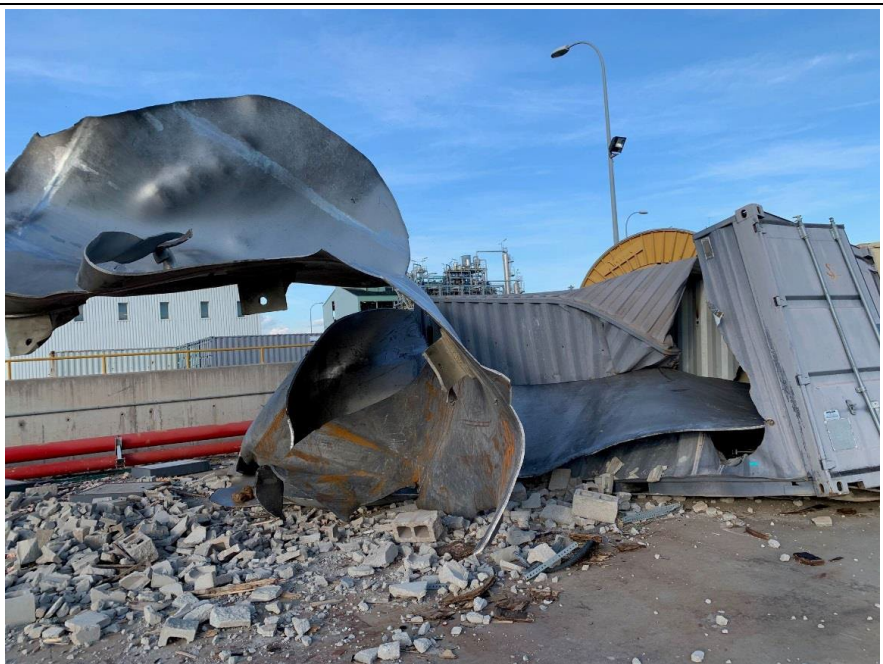
Figure 7-5: FOTOGRAFIA 262

One of the fragments has been identified as the wall of the reactor. See Figure 7-5. There are two drilled supports visible in the photograph. Their shapes are consistent with the design of the support bases of the reactor normally positioned on the exterior of the cylindrical wall, 500mm above the tan line. The photo shows the inside wall in the area of these supports to be shiny and clean.

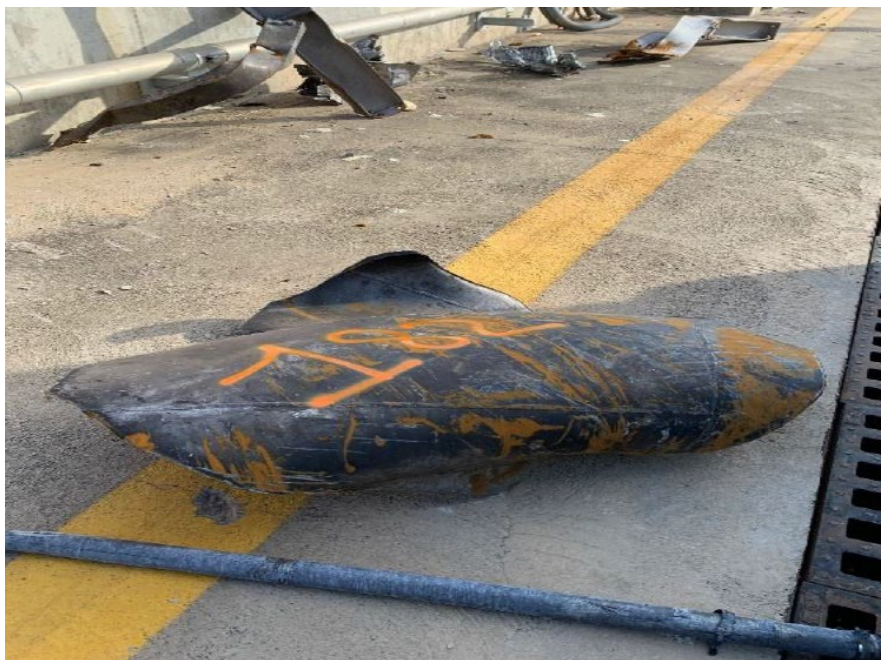
Figure 7-6: FOTOGRAFIA 182

Figure 7-6 shows a piece of distorted welded metal plate. At the time of writing it has not been identified. It appears to have been fire damaged prior to ejection by the blast. This fragment could be significant if it is part of the reactor R-3131, since it would imply at least partial exposure of the reactor to fire.

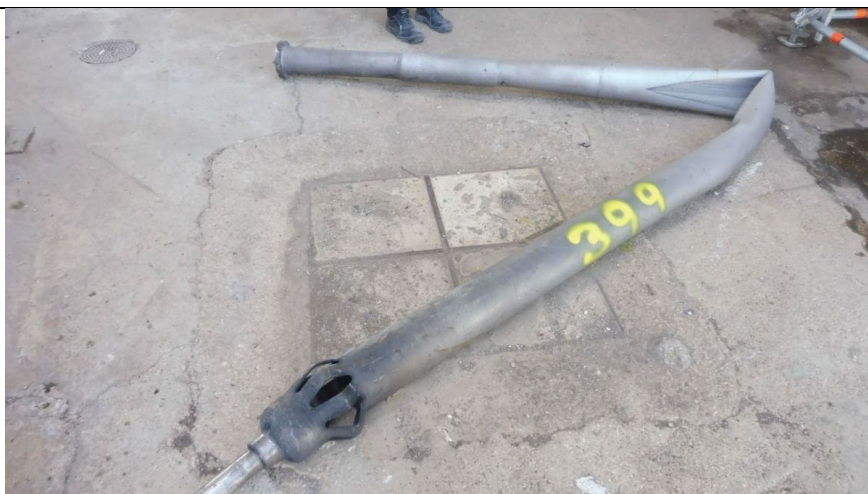
Figure 7-7: FOTOGRAFIA 399

Figure 7-7 shows a piece of pipe that has been exposed to heat.
