CHEMICAL EXPLOSION AT IQOXE IN TARRAGONA

Incident Investigation Report

Report No.: 2020-9184, Rev. 1

Date: 2020-10-09

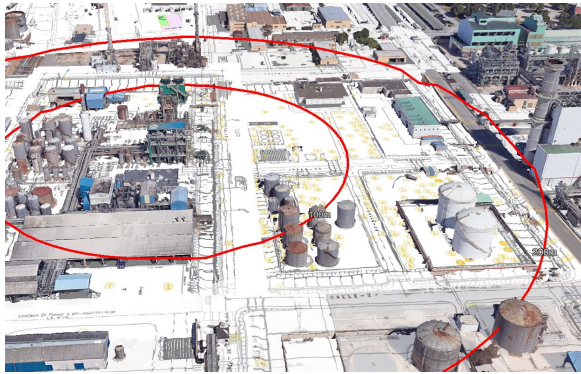
Figure 4-6: Zone 0 and 1 at IQOXE plant

Damage by missiles and fragments travelling

The missile with the largest travel distance belongs to the lower section of the reactor R3131 and travelled about 2.5km.

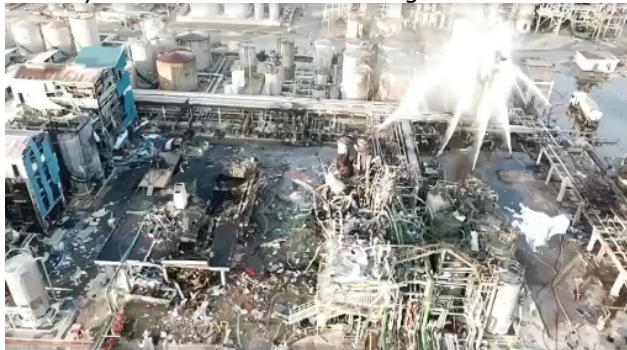
Figure 3-5: Excerpt from video showing the destroyed U3100 and surrounding facilities

The blast wave “cut-off” the upper two levels of the U3100.

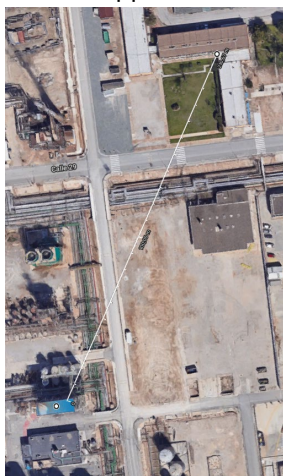
Figure 4-11: Distance from incident site to IQOXE office building

Windows were shattered in the office building located approx. 200m away.

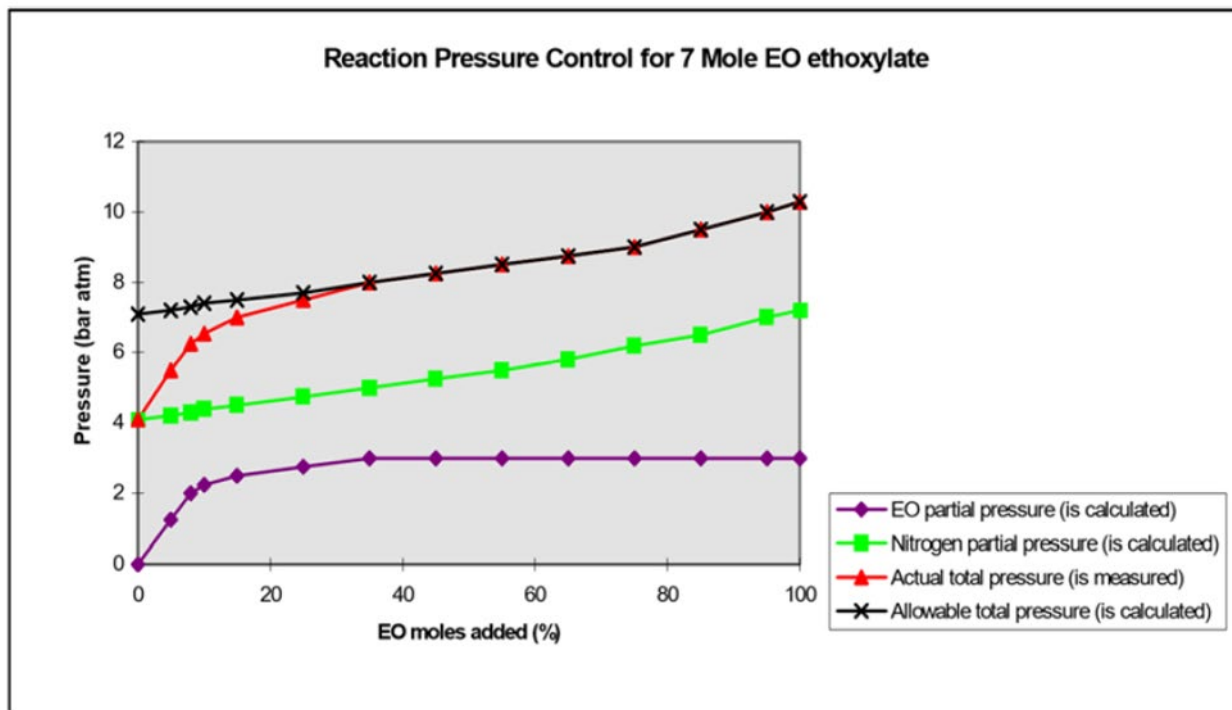
The following graph in Figure 4-15 demonstrates the profiles of the measured and calculated partial and total pressures. It is important to note that the partial pressure of EO remains flat during the reaction and does not reach 50% of the total pressure.

It is possible that this control of EO concentration could be at fault. There is no chemical analysis of the gas phase so if part or all the initial nitrogen were replaced by EO, this would not be detected by the control system and its algorithm whilst the pressure is maintained. Possible scenarios are:

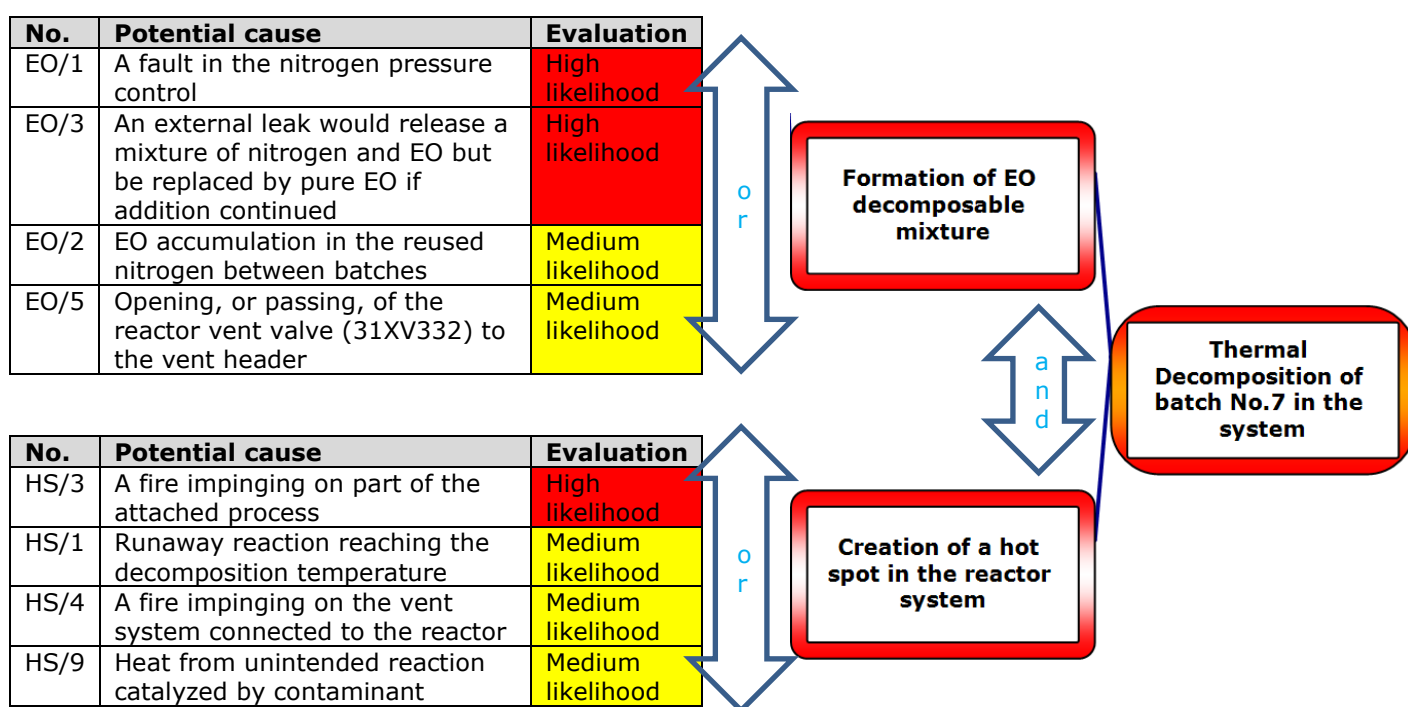
Figure 4-21 Summary of hypotheses

No.	Potential cause	Evaluation
EO/1	A fault in the nitrogen pressure control	High likelihood
EO/3	An external leak would release a mixture of nitrogen and EO but be replaced by pure EO if addition continued	High likelihood
EO/2	EO accumulation in the reused nitrogen between batches	Medium likelihood
EO/5	Opening, or passing, of the reactor vent valve (31XV332) to the vent header	Medium likelihood

No.	Potential cause	Evaluation
HS/3	A fire impinging on part of the attached process	High likelihood
HS/1	Runaway reaction reaching the decomposition temperature	Medium likelihood
HS/4	A fire impinging on the vent system connected to the reactor	Medium likelihood
HS/9	Heat from unintended reaction catalyzed by contaminant	Medium likelihood

The investigation has not yet been able to identify the actual causes or the common cause for the two events leading to the thermal decomposition, due to the previously mentioned constraints.

Figure 4-21 summarises the different combinations of causes leading to the two requirements for the decomposition: a heat source and formation of a decomposable mixture in the reactor. In this summary, potential causes have been omitted where the likelihoods are considered low for this particular accident.

Certain causes in the two branches may have a common origin. For example, a leak of EO is likely to ignite and provide the heat source as well as provide a mechanism for enrichment of the gas mixture in the reactor.

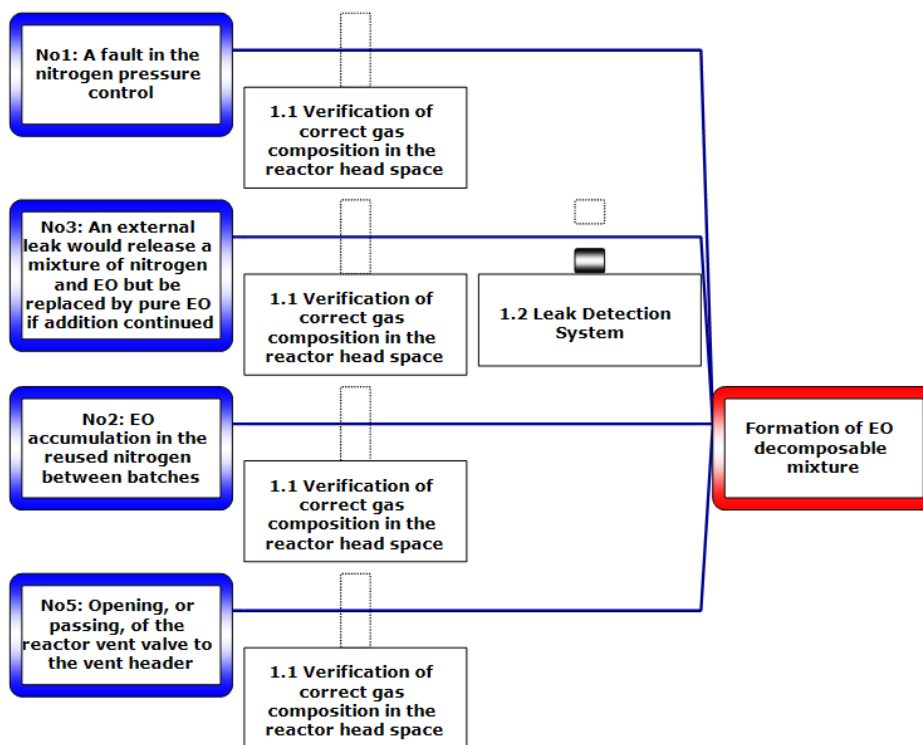
Barrier 1.1, "Verification of correct gas composition in the reactor head space"

Barrier Analysis -	
Intention of the barrier	To measure the concentration of EO in the head space of the reactor. If the concentration exceeds a defined safety level, to activate an alarm to warn the operators and automatically stop the EO feed pump and close the EO feed valves.
Actual barrier behaviour	<p>Missing barrier</p> <p>The EO concentration in the reactor head space is not measured. However, to ensure the correct gas composition, the system is pressurised nitrogen prior to the EO supply and the system continuously controls EO partial pressure with an algorithm.</p> <p>Currently it is not standard practice in ethoxylation reactor design to provide a gas analyser on the head space. There would be a number of practical difficulties in providing such analysis including the impact of polymer contamination on the analyser. There will be no further analysis of this barrier except to recommend that IQOXE liaises with other ethoxylation operators to review developments in this area and adopt new technology if appropriate.</p> <p>(Recommendation 7)</p>

Improvement area in management system	Process Hazard Analysis to determine risks and needs and location for gas detection. (Recommendation 6)	3.8	Process Hazard Analysis
References			
PAP_005	P15 Pruebas de Puesta en Parcha y Proyecto de Instalacion U-3100, Nov 2016 includes test certificates.		
PAP_043	ACC OE guide		
PAP_018	Safety Concept

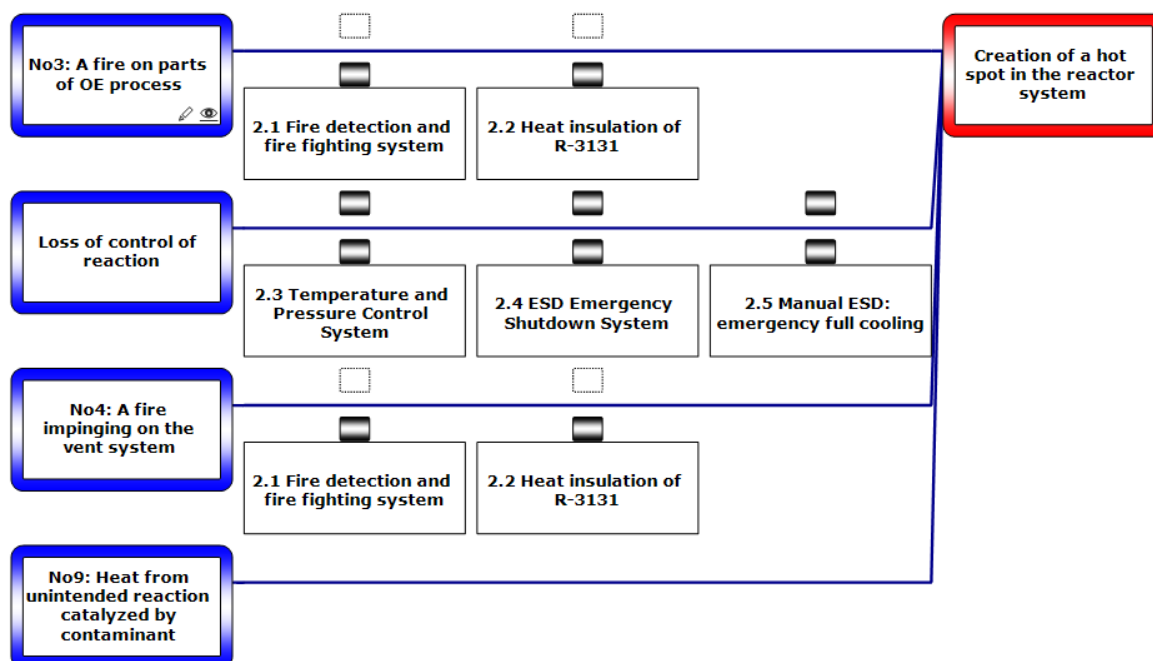
Barrier 2.1 „Fire detection and fire fighting system“

Barrier Analysis -	
Intention of the barrier	To detect the onset of fire, including small fires that produce mainly smoke. Once activated, an alarm is initiated to warn the operators and start emergency procedures. On confirmed detection, fire extinguishing media are started automatically (e.g. fire pumps and water sprinklers).
Actual barrier behaviour	<p>Inadequate barrier</p> <p>According to photographs and design documents provided, the unit U-3100 was provided with a sprinkler system located around the reactor R-3131 designed to cool the reactor surface in the event of fire impingement. The sprinkler system extends also to the post-treatment vessel. The sprinklers are activated by heat sensitive bulbs fitted to the sprinkler heads.</p> <p>The fire detection and firefighting systems have been designed and installed in line with Spanish regulations for industrial buildings. The process area is classified for intrinsic risk with $C_i=1.6$ (high risk) and Type D according to Annex I of the Fire safety Regulations for Industrial Establishments (Real Decreto 2267/2004, de 3 de diciembre, por el que se aprueba el Reglamento de seguridad contra incendios en los establecimientos industriales.).</p> <p>Accordingly, a manual fire alarm system and fire extinguishers have been selected as protection measures. Automatic fire detection systems as well as automatic water sprinkler systems were not selected, as they are not required for type D and E installations by the stated regulation.</p> <p>Whilst smoke detectors have been installed in the technical room and control room buildings, no evidence has been seen of any additional fire, heat, flame or smoke detection in the process building.</p> <p>Photographs show some fire monitors located around the unit U-3100.</p>

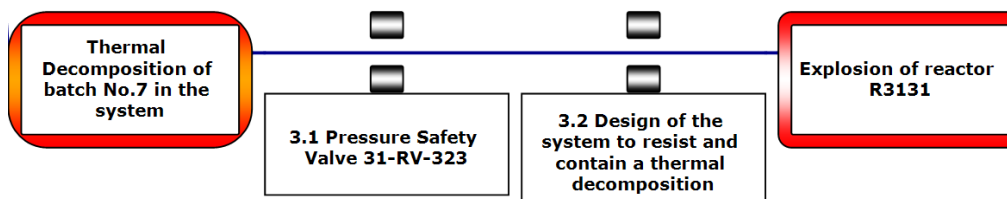
Barrier 3.1 „Pressure Safety Valve 31-RV-323“

Barrier Analysis	
Intention of the barrier	A pressure safety valve (PSV) shall protect the system from rupturing due to overpressure generated from process conditions or exposure to fire heat loads.
Actual barrier behaviour	<p>Inadequate barrier</p> <p>The pressure safety valve 31-RV-323 (3 inch) is designed for an overpressure scenario caused by a fire impinging on the reactor building up methanol vapour pressure in the system, without consideration of a runaway reaction or thermal decomposition. For a rapid pressure build-up (25 bar/s for 60% EO according to Braithwaite), as in the case of a thermal decomposition, it will not be able to relieve the pressure from the system.</p> <p>It may be the case that during the accident, the PSV lifted and released gas from the system for a certain time. A witness from the IQOXE plant mentioned a loud noise for approx. 10-15 seconds that sounded like a depressurisation sound, such as from a PSV relief.</p> <p>The function tests, external and internal, are not considered in the barrier assessment, as by design the PSV is considered inadequate for protection against a thermal decomposition. The high rate of pressure rise means that protection using pressure relief would not be possible. No further BSCAT analysis is provided for this barrier, therefore.</p>

Causal Analysis			
Specific Description			Reference DNV GL SCAT Classification
Direct Cause:	The system does not protect from all scenarios of decomposition.	27	Inadequate Integrity of Equipment
Basic Cause(s):	Insufficient detail and time spent on identifying scenarios of decomposition that would not be contained by the reactor.	14.1	Inadequate assessment of needs and risks
Improvement area in management system	Identify and assess risks of scenarios of decomposition that would not be contained by the reactor. Ensure levels of safeguards in place are sufficient when the containment is excluded. (Recommendation 4)	3.8	Process Hazard Analysis
References			
PAP_018	Safety Concept		
PAP_043	ACC OE guide (regarding theory on thermal decomposition pressure development)		
PAP_005	P15 Pruebas de Puesta en Parcha y Proyecto de Instalacion U-3100, Nov 2016 includes test certificates.

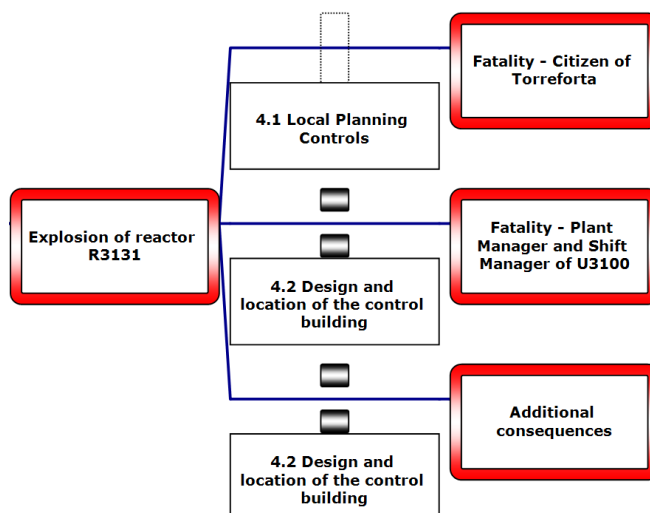
Barrier 4.1 „Local Planning Controls”

Barrier Analysis	
Intention of the barrier	To ensure that risks are acceptable for: <ol style="list-style-type: none"> 1. New businesses, residences or public buildings proposed to be developed adjacent to major hazard installations such as U-3100; 2. Proposed new major hazard installations to be developed adjacent to existing businesses, residences or public buildings.
Actual barrier behaviour	<p>Inadequate barrier in in this particular accident where the serious consequences of the atypical projection of a fragment would have had a very low predicted likelihood. Possibly adequate for managing the predicted risks to a normally acceptable level, but this aspect was not part of the investigation.</p> <p>Land use planning controls by the local authorities is assumed to be based on risk or consequence modelling. LUP should evaluate risk acceptability for surrounding locations. Both risk or consequences-based approach include explosion impact assessment where explosion hazards are identified. Explosions related damage may result from overpressure, impulse, missiles and shrapnel. Following international guidelines and standards, overpressure levels are generally considered the most critical measurement since they have a 360 degree effect and pose a higher probability of impacting a specific receptor. No specific LUP report for the Unit 3100 project has been provided to DNV GL but, usually, LUP is based on overpressure level calculation and does not include specific missiles risk assessment and so no definition of mitigation measures is required.</p> <p>Given the number of ethylene oxide explosions that have occurred in history and the incidence of missile fragments, DNV GL would recommend that this approach is reviewed to see whether risk criteria and mitigation of the type used for explosive manufacturing sites should be adopted at least for new installations. This would require joint, international review amongst manufacturers that use ethylene oxide and their regulators. (Rec. 8)</p> <p>No further BSCAT analysis is provided for this barrier.</p>

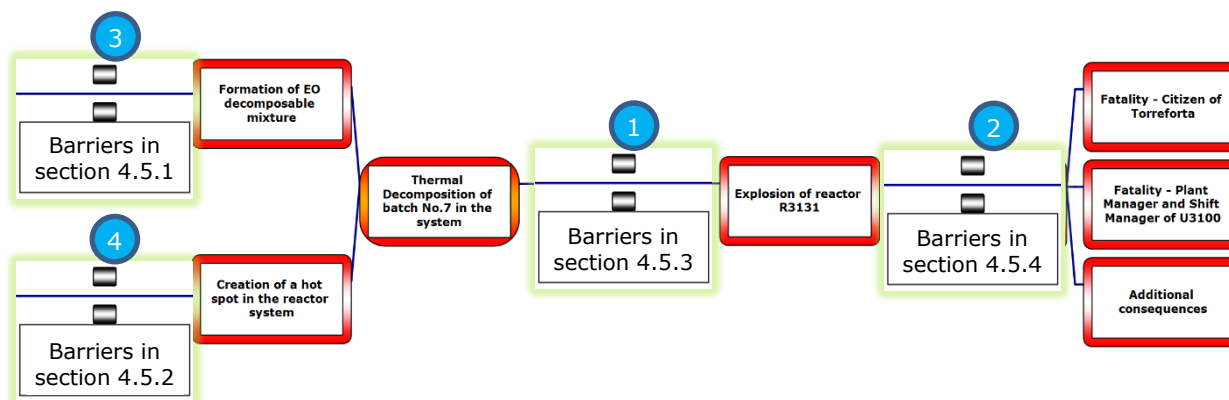
Figure 4-22: Conclusions on Barrier Assessment

2	<p>Barriers to prevent or mitigate the consequences from the event "Explosion of reactor R3131"</p> <p>There are only very few mitigating barriers to reduce the consequences from the major event.</p> <p>The barrier 4.1 „Local Planning Controls" to protect external parties is regarded as inadequate to stop the sequence of events in this particular accident where the serious consequences of the atypical projection of a fragment would have had a very low predicted likelihood. The barrier 4.1 „Local Planning Controls" may be adequate for managing the predicted risks to a normally acceptable level, but this aspect was not part of the investigation.</p> <p>The second identified barrier to protect people working on site in the control room, 4.2 „Design and location of the control room" failed, as there is no evidence that the risks to the persons in the control room from the new unit U3100 had been fully assessed, neither by management of change, nor by occupied building risk assessment.</p> <p>As it becomes obvious from the limited prevention and mitigation barriers, an incident like this must be prevented by all means before a thermal decomposition is initiated.</p>

3	<p>Barriers to prevent the event "Formation of EO decomposable mixture"</p> <p>The barrier 1.1 „Verification of correct gas composition in the reactor head space" is not in place (missing), however, currently it is not standard practice in ethoxylation reactor design to provide a gas analyser on the head space. There would be a number of practical difficulties in providing such analysis including the impact of polymer contamination on the analyser.</p> <p>The barrier 1.2 „Leak detection system" has been regarded as inadequate. The leak detection provided in the facility appears to be insufficient. No evidence has been seen that relevant safe studies were performed and that relevant guidance was applied in selection or location of leak detection.</p>
4	<p>Barriers to prevent the event "Creation of a hot spot in the reactor system"</p> <p>Barrier 2.1 „Fire detection and fire fighting system" is considered inadequate. The installed sprinkler system only protected the reactor vessel, but not the entire EO connected system in U3100.</p> <p>No evidence was seen of safety studies to identify possible fire sources in U3100, that might affect the EO-connected system, nor was evidence seen of identification of required active or passive fire protection other than a design document based on industrial building regulatory requirements.</p> <p>Barrier 2.2 „Heat insulation of R-3131", Barriers: 2.3 „Temperature and Pressure Control System", 2.4 „ESD Emergency Shutdown System" and 2.5 „Manual ESD: emergency full cooling":</p> <p>Due to the extent of damage to the unit and the lack of data or witness information, it is not possible to determine if there was a failure of the systems or the manual ESD activation. However, such a failure is credible but low likelihood.</p>

Group No.	Barrier assessment
1	<p>Barriers to prevent the event "Explosion of reactor R3131" after the event "Thermal Decomposition of batch No.7 in the system" occurred</p> <p>Once the thermal decomposition has started, it will immediately result in a major event. There are no preventive barriers known by DNV GL, that could effectively stop the thermal decomposition from progressing to an explosion.</p> <p>Existing barriers, such as 3.1 "Pressure Safety Valve 31-RV-323", or 3.2 "Design of the system to contain a thermal decomposition" were inadequate for this event. The barrier 3.2 could cope with thermal decompositions not reaching more than 45barg.</p>
2	<p>Barriers to prevent or mitigate the consequences from the event "Explosion of reactor R3131"</p> <p>There are only very few mitigating barriers to reduce the consequences from the major event. In this case, the barrier 4.1 „Local Planning Controls" to protect external parties is regarded as inadequate. It would possibly be adequate for managing acceptable risk. The second identified barrier to protect people at IQOXE site working in the control room, 4.2 „Design and location of the control room", unfortunately failed, as the risk from the new unit U3100 have not been dealt with, neither by management of change, nor by risk management.</p> <p>As it becomes obvious from the limited prevention and mitigation barriers, an incident like this must be prevented by all means before a thermal decomposition is initiated.</p>

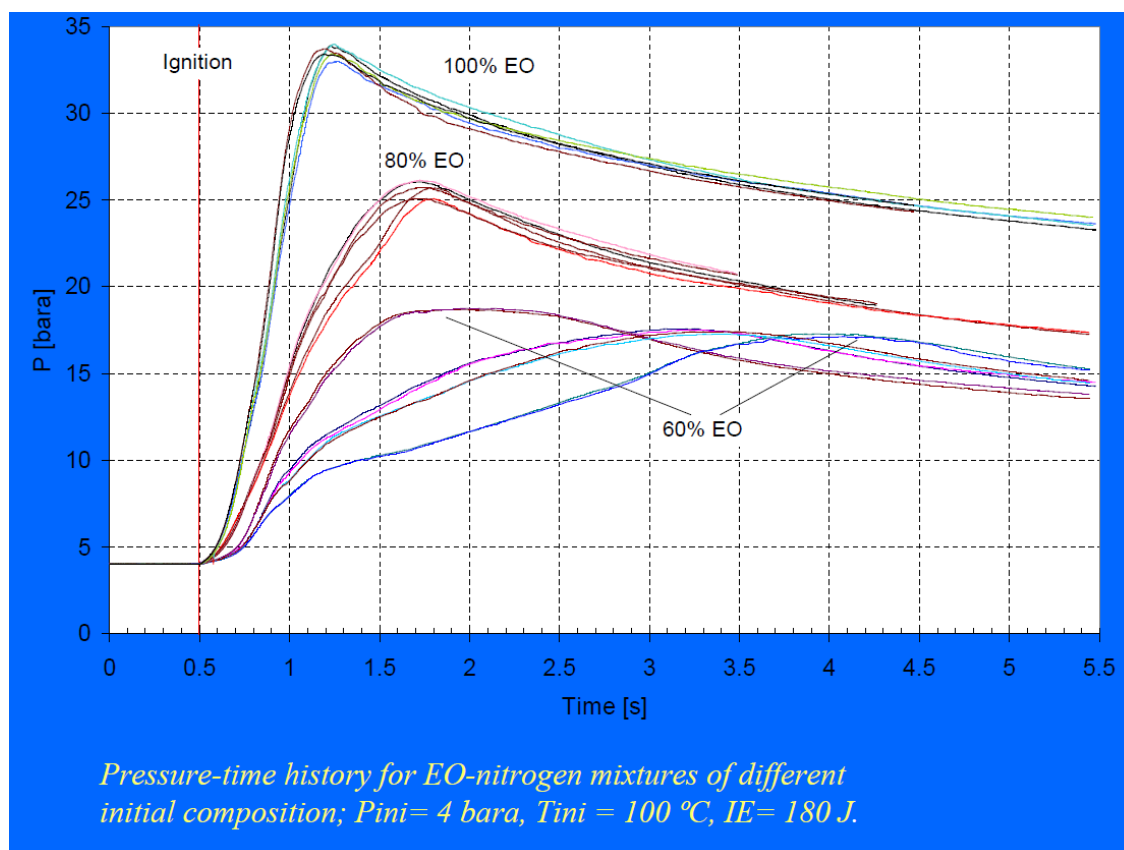
Experiments in a 20L sphere, reported by Braithwaite and Pekalski¹, show that the gases released by the decomposition plus the rise in temperature cause a rapid rise in pressure. The final pressure depends on:

Figure 7-1: Pressure increase for EO-nitrogen mixtures of different initial composition

The final pressure at the end of a normal reaction in the reactor is expected to be about 11barg= 12bara. In a deviation where the gas mixture had become 100% EO, the maximum decomposition pressure might be expected to reach $12 \times 9 = 108\text{bara}$ which largely exceeds the design pressure of 46bara and also the test pressure of 68.5bara. If not relieved, this pressure would very likely rupture the reactor system.

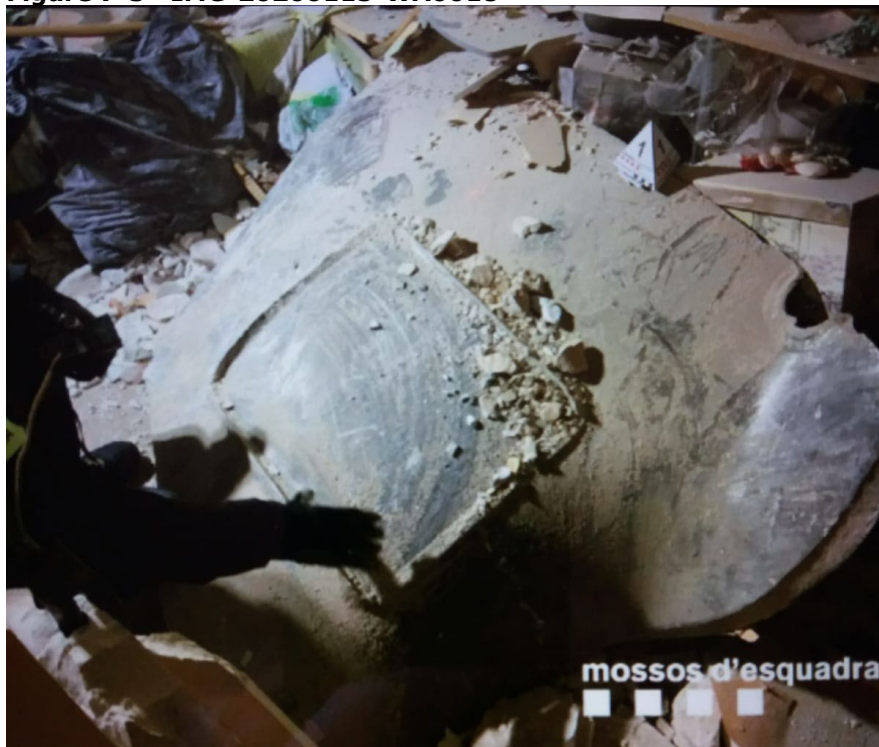
Figure 7-3 IMG-20200115-WA0018

Several fragments that appear to be associated with the reactor do not show fire damage. Examples are the fragment of reactor wall that struck Pza Garcia Lorca, 20 and what appears to be the large jet head assembly. These are shown in Figure 7-3 and Figure 7-4. The large jet assembly does not appear to have any signs of combustion products (black soot) on its interior surfaces.

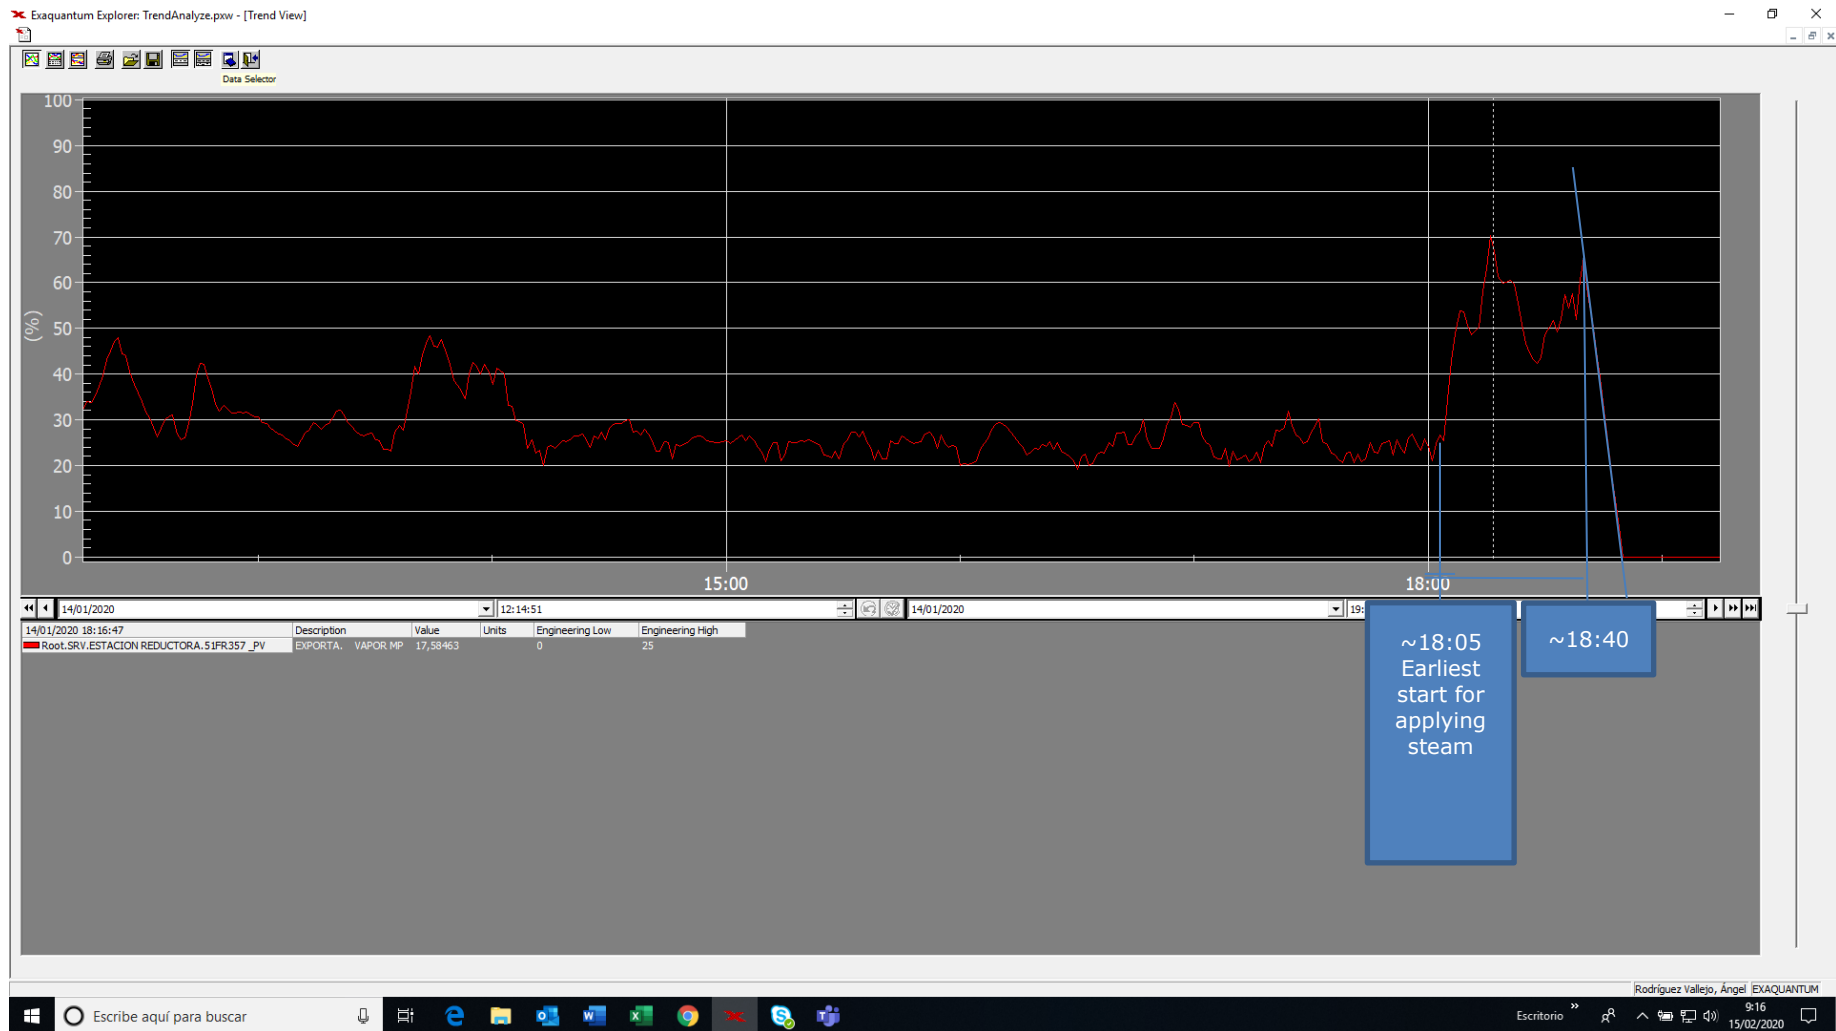
Figure 8: Steam for entire IQOXE plant

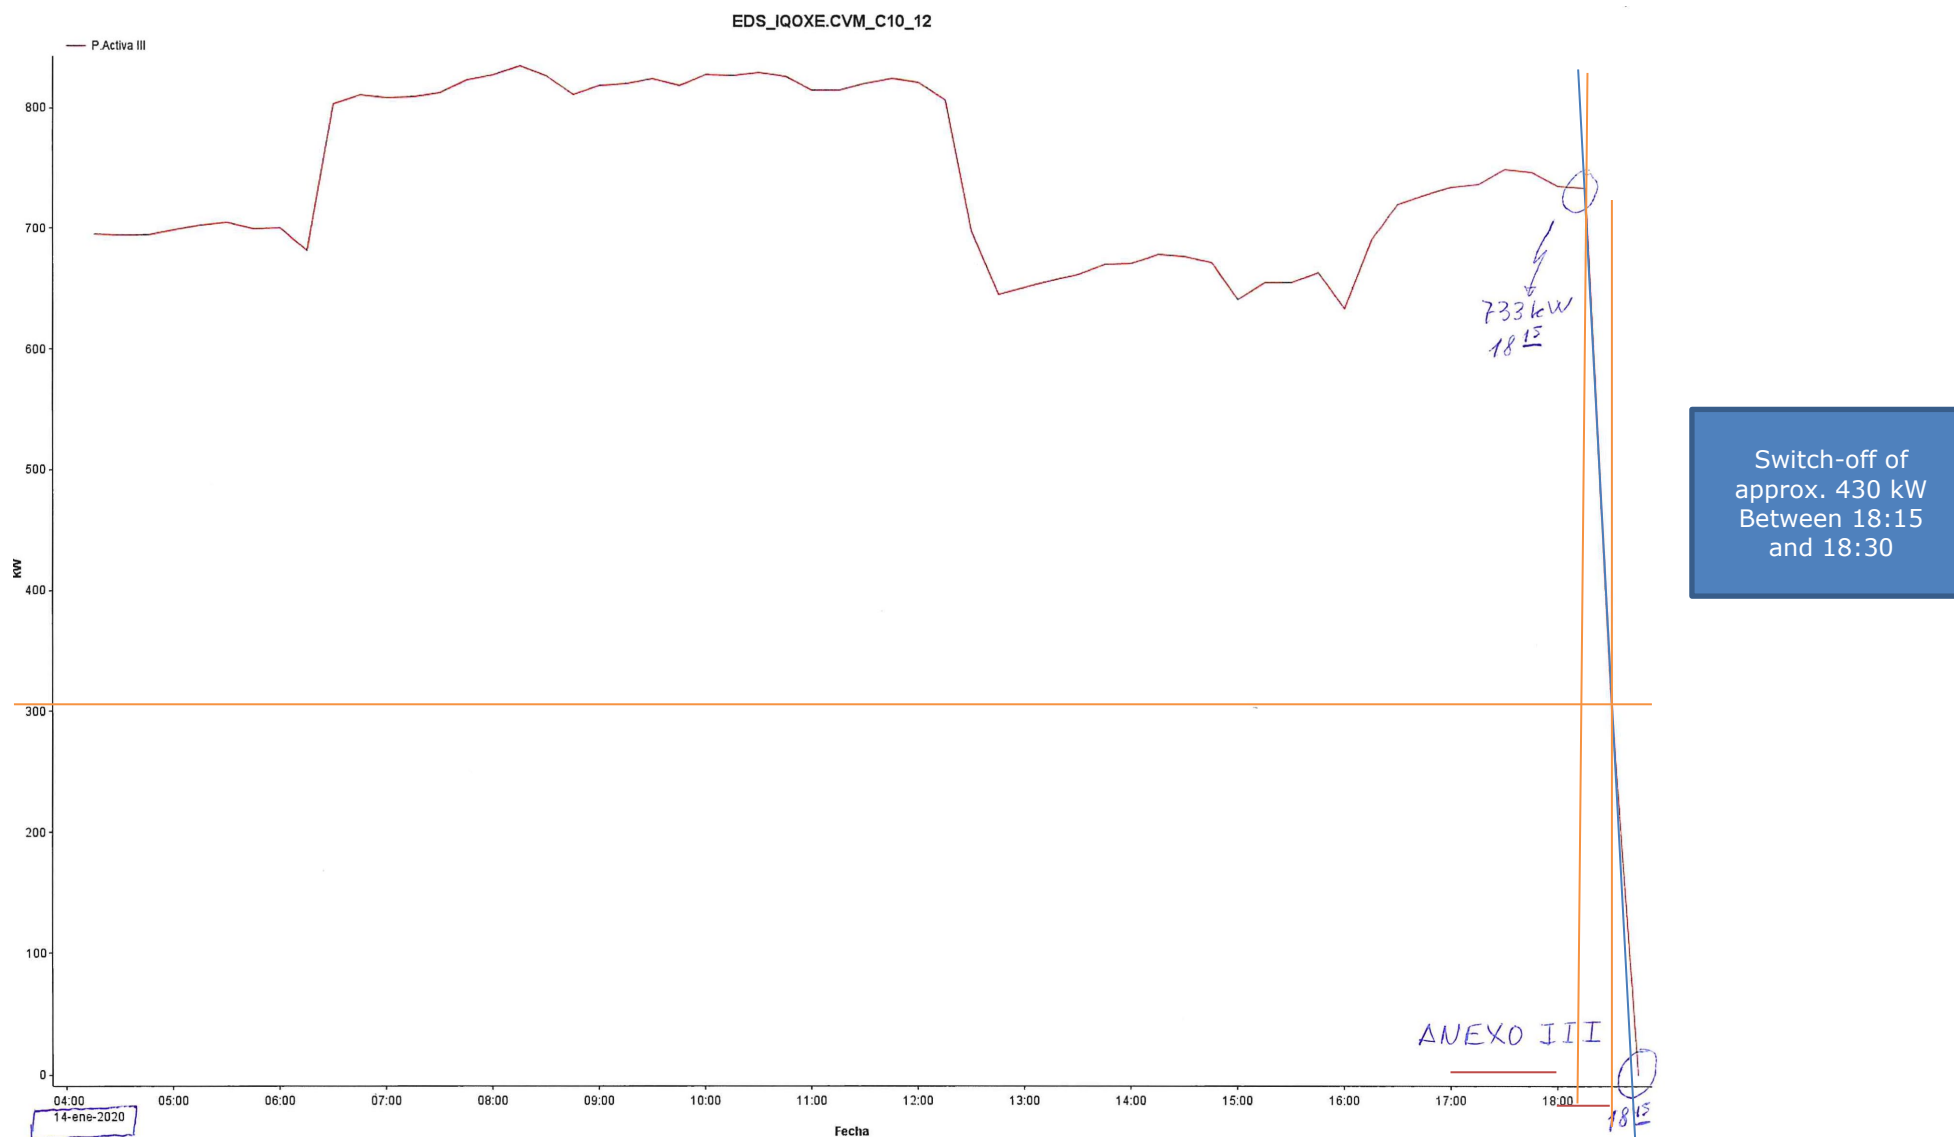
Figure 9: Electrical consumption of U3100 on 14th of January 2020
